Docket No. 217 – Development and Management Plan Inspection

Northeast Utilities Service Company Certificate of Environmental Compatibility and Public Need for the construction of a 345-kV electric transmission line and reconstruction of an existing 115-kV electric transmission line between Connecticut Light and Power Company's Plumtree Substation in Bethel, through the towns of Redding, Weston, and Wilton, and to the Norwalk Substation in Norwalk, Connecticut.

Location: 345kV XLPE Component

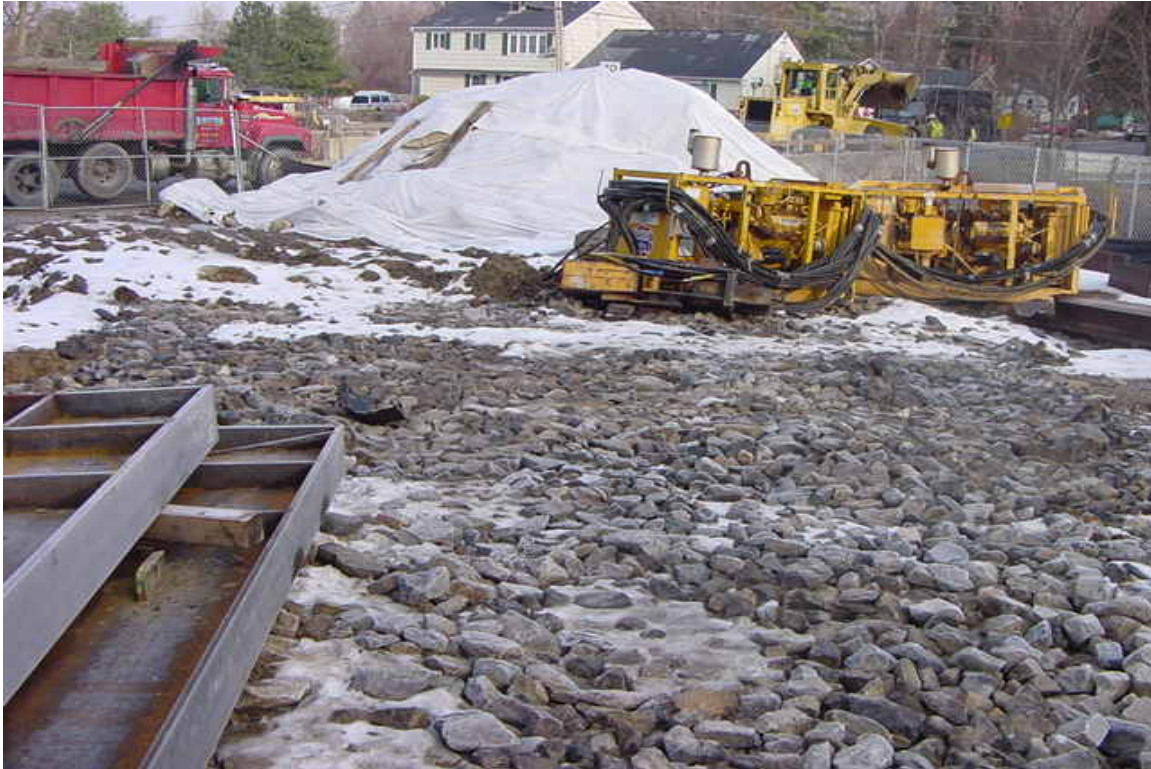
345kV XLPE (Jack and Bore): Overall view of the site with additional stone in place. The stockpile is well covered and equipment had mobilized to the other side of the intersection. 1/12/06
